# CONSULTATION SERVICES TO RESPOND, RECTIFY, AND RESTORE

## ON THE JOBSITE

### THE PROBLEM

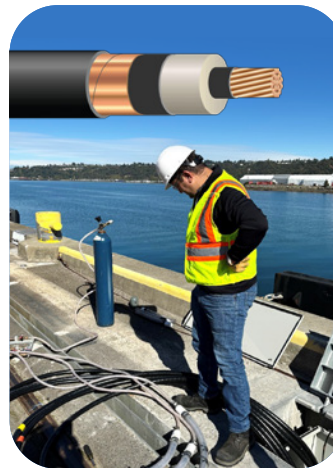
The wet MV power cables were purged using a compressed nitrogen gas tank on-site at the docking station. Three sets of cables were simultaneously purged using a custom-built manifold.

Our engineers traveled to the port and inspected the cable first to ensure that there was no installation damage. Our field experts purged the new cable using compressed nitrogen gas to push out the rainwater. Due to the cable size and length, the purging took a few days to conclude. The complete moisture removal was verified via a color-changing desiccant. The restored dry cable will operate as designed, and the product's manufacturing warranty is still valid.

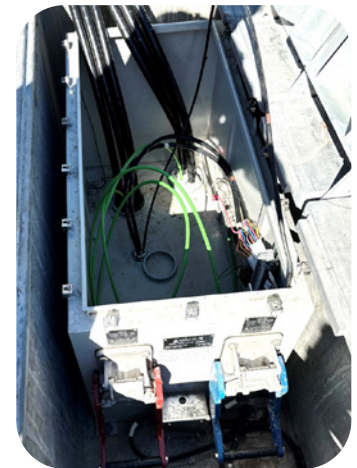
The cables were dried, restored to their original state, and then terminated in the power distribution box. The installed cables also passed Acceptance Testing and are ready to deliver critical shore power for many ships that will dock at the port.
