EXTENDING THE LIFE OF SECONDARY SERVICE CABLE THROUGH SILICONE GEL-INJECTION

Written by: James Steele, Director of Engineering; David Busby, PhD, Polymer Chemist; & Nathan Laurie, Field Sales Engineer

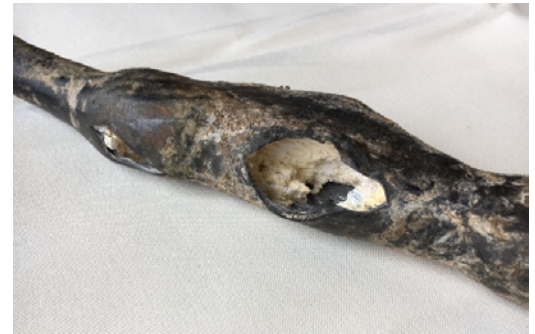
Fig. 1. Full loss of ampacity of a secondary service cable due to corrosion of the aluminum conductor.

Small surface irregularities of the conductor combined with oxygen, water, and electrolytes to result in pitting corrosion and the formation of aluminum hydroxide. Due to the higher specific volume of the corrosion products compared to pure aluminum, swelling and deformation of the cable can occur as shown in Figure 1. Corrosion of the conductor leads to the potential failure of the segment through high resistance and a reduction of the cable's ampacity. The fundamental equations for the corrosion mechanism are provided in below in (1) and (2) and have been well documented in literature [3] and [6].

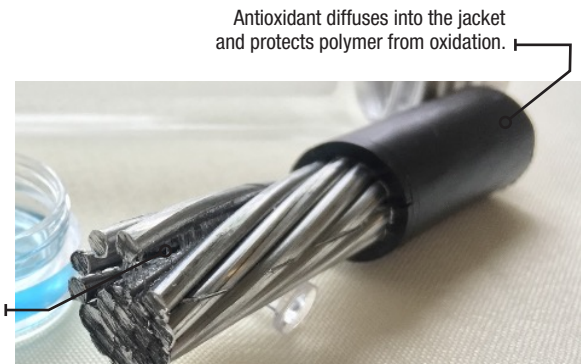
Fig. 3. Silicone gel is a unique two-part material that transforms from a easy-flowing mixture into a non-flowable gel in approximately 48 hours.

The catalyzed reaction transforms the fluid from a easy-flowing mixture with a viscosity of 5cS into a non-flowable gel in approximately 48 hours (Figure 3). The low viscosity allows for an average injection time of less than one hour. This silicone gel is hydrophobic and protects the cable against corrosion by first flushing standing water from the cable conductor. Once the silicone gel has cured, the gel will protect the conductor from water ingress through any opening that occurs in the jacket.

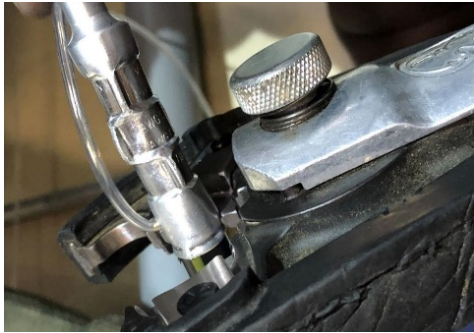
Fig. 4. Injection connectors are installed at each cable end to create a fluid access point for injecting silicone gel into the cable's conductor.

Injection connectors are proprietary devices installed at the cable ends (Figure 4). They provide controlled fluid access to the conductor while creating the electrical connection that joins the cable's conductor to the secondary buss. At the meter, the injection connectors are reconnected to the supply side of the of the buss (Figure 5). The flexible tubes from the injection connectors are routed to the collection tank, and the meter is reassembled and returned to service. At the transformer, the flexible tubes are routed to the pump that makes up the fluid delivery system discussed in the next section.
